# Colorado Cultural Resource Survey Architectural Inventory Form

1. Resource Number: **5PT903**
2. Temporary Resource Number: **Not Applicable**
3. County: **Pitkin**
4. City: **Aspen**
5. Historic Building Name: **Louis and Mary Peters Cabin  
William and Hildur Anderson Residence  
Anderson Stables**
6. Current Building Name: **Anderson Park**
7. Building Address: **1101 E. Cooper Ave.  
Aspen, CO 81611**
8. Owner Name & Address: **City of Aspen  
130 S. Galena St.  
Aspen, CO 81611**

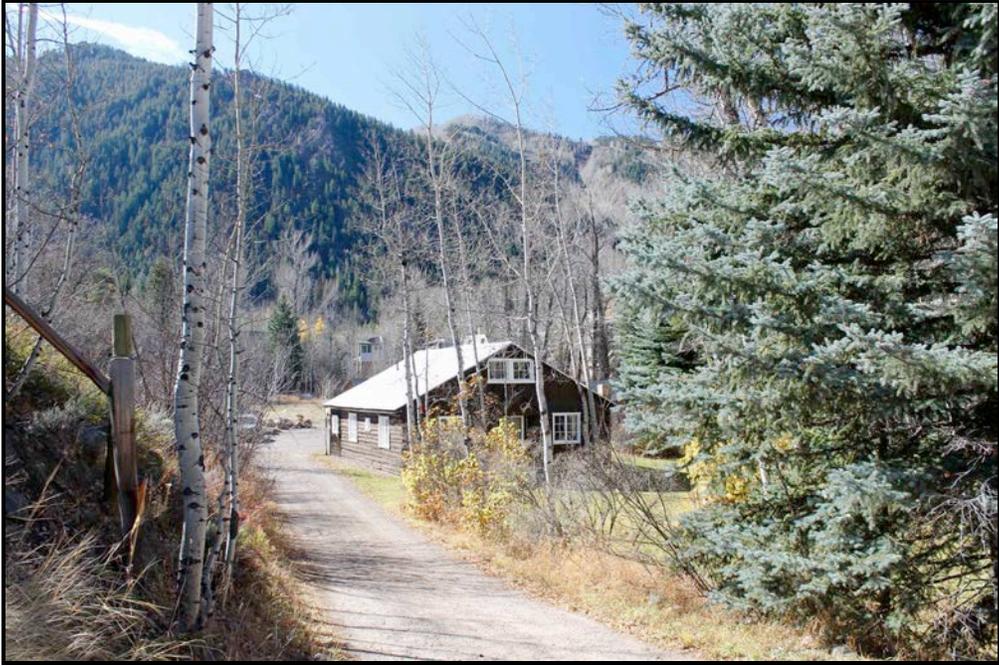
**General View of the Property from Cooper Avenue  
View to the South-Southwest**

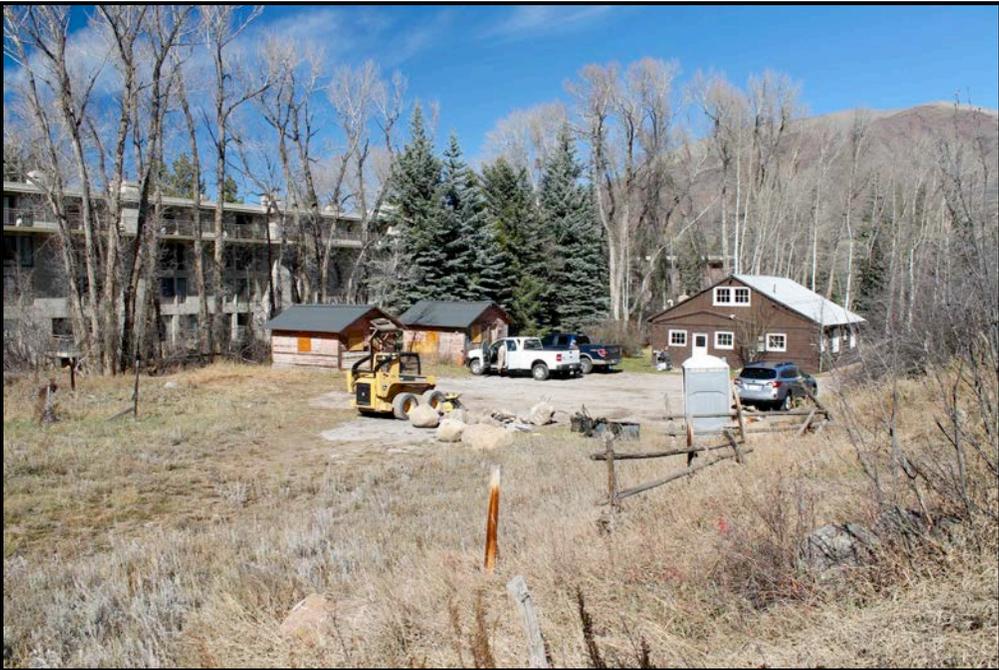
**General View of the Property from the Southeast  
View to the Northwest**

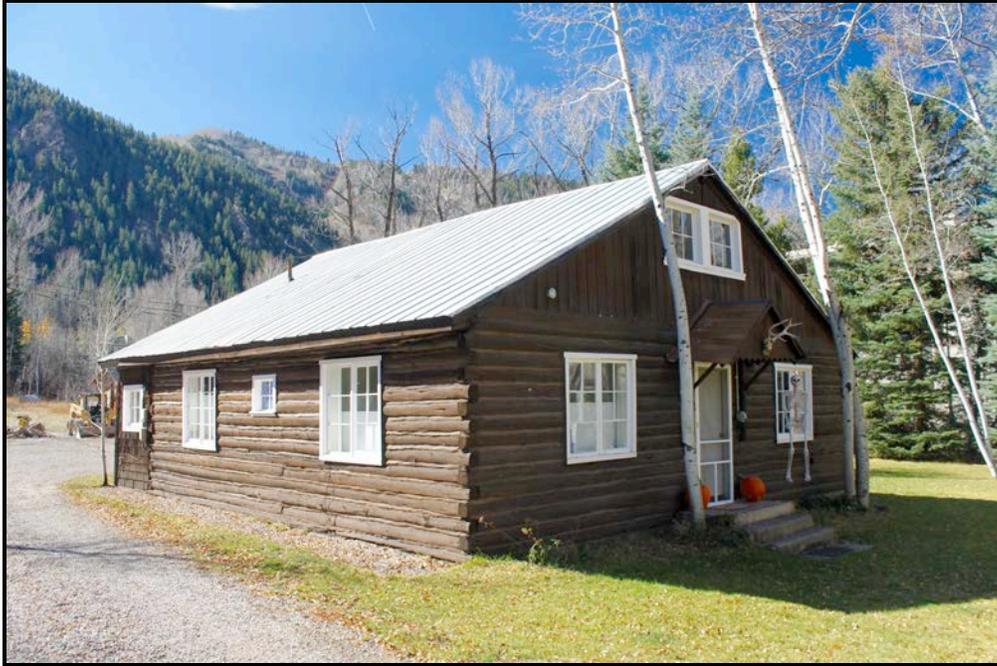
**East (side) and North (front) Walls of the Log Residence  
View to the Southwest**

North (front): The front of the building holds the centered main entry, which is accessed by way of a small stoop. The stoop is constructed of concrete with pieces of flagstone set into the upper surfaces. The entrance contains a panel door (probably non-historic) and a wood screen door, both set into a wood frame. Mounted above the entry and stoop is a rustic hood that projects from the wall to provide shelter from the elements. This is supported by slender log bracing that is attached to the building's primary log wall. The hood's front-gabled roof consists of lumber rafters, fascia boards, and asphalt shingles. Its end wall is finished with vertical tongue-in-groove boards that are shaped along the bottom for a decorative sawtooth finish.

Flanking the entry are two identical pairs of six-light casement windows. The attic level above holds a single centered pair of six-light casement windows. All of the windows are set in wood frames and surrounds. The gable end wall surrounding the upper windows is finished with vertical board paneling.

East (side): This side of the building abuts the driveway and holds no entries. Several windows are present along the wall. On the primary log portion of the building are a pair of six-light casements, one small four-light casement (this may be fixed in place), and a pair of eight-light casements. The rear enclosed porch contains one six-light casement window. All of these are set in wood frames and surrounds.

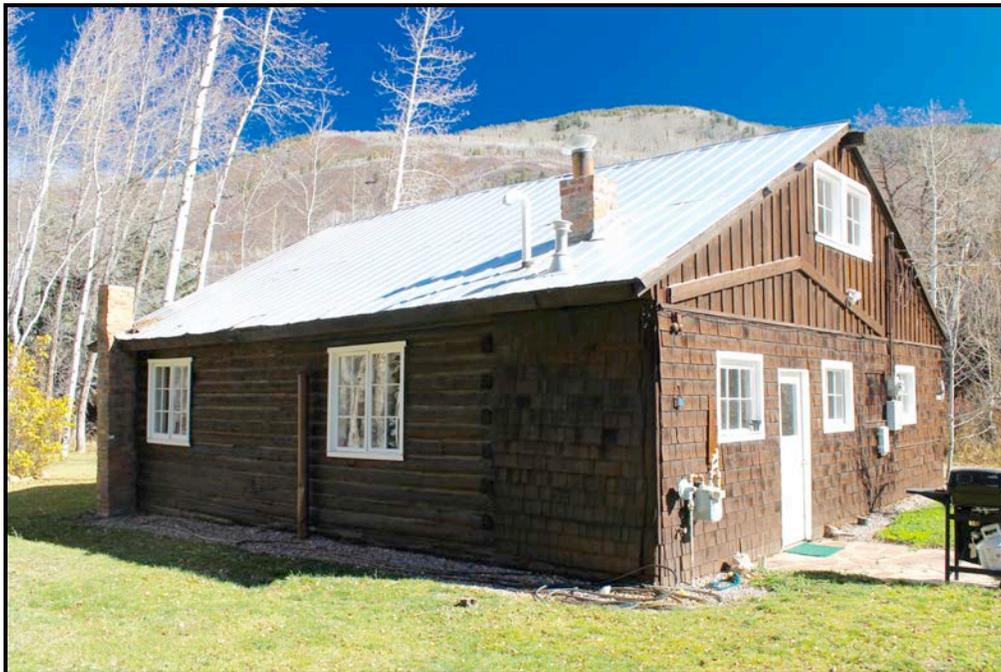
**West (side) and South (rear) Walls of the Log Residence  
View to the Northeast**

**South (rear):** The rear of the building holds an enclosed porch that is constructed with dimensional lumber atop a concrete slab. This is tucked below the primary roof and attic level. The exterior walls of the porch are finished with square butt cedar shingles.

**West (side):** This side of the building holds no entries. Aside from the brick chimney described above, it is characterized by the presence of two pairs of six-light casement windows with wood frames and surrounds.

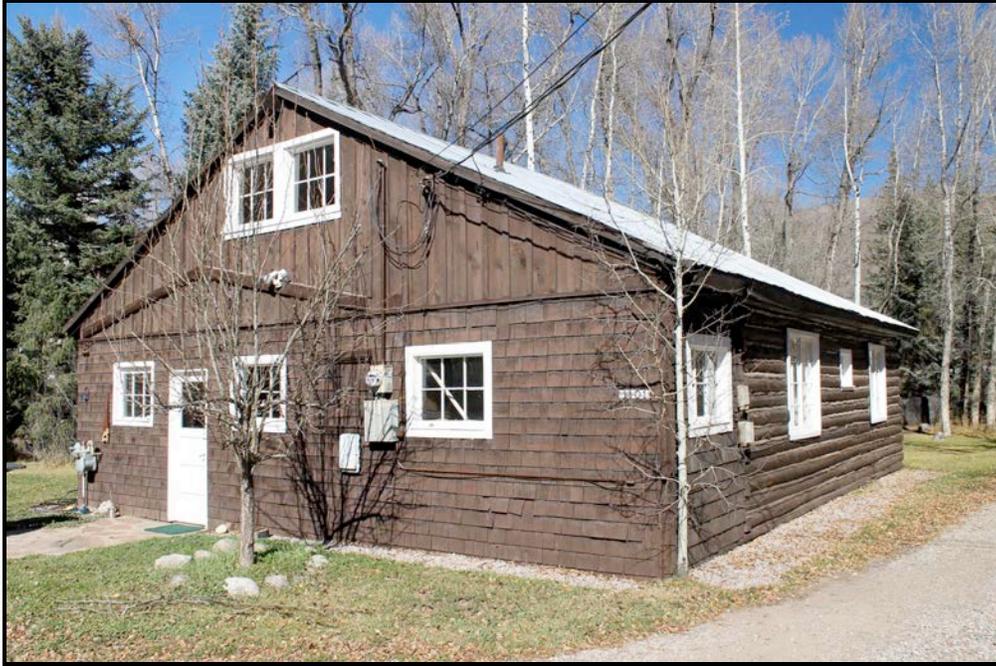
**South (rear) and East (side) Walls of the Log Residence  
View to the Northwest**

The off-centered entrance contains a wood panel door with a single light. Flanking the entry are two six-light casement windows, and another six-light casement is found further to the east along the wall. All of these have wood frames and surrounds. Also present east of the entry is another historic window that has been boarded closed and shingled, but retains its unpainted wood surrounds. The ground immediately outside of the entrance is paved with concrete and slabs of flagstone.

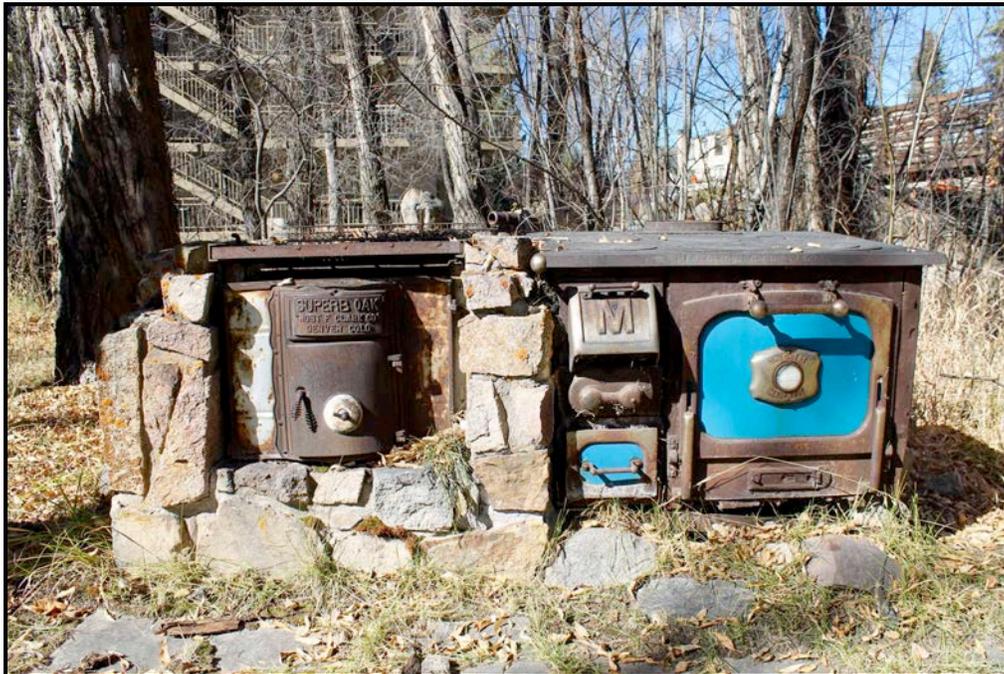
**View of the Cook Stoves in the Front Yard  
View to the West**

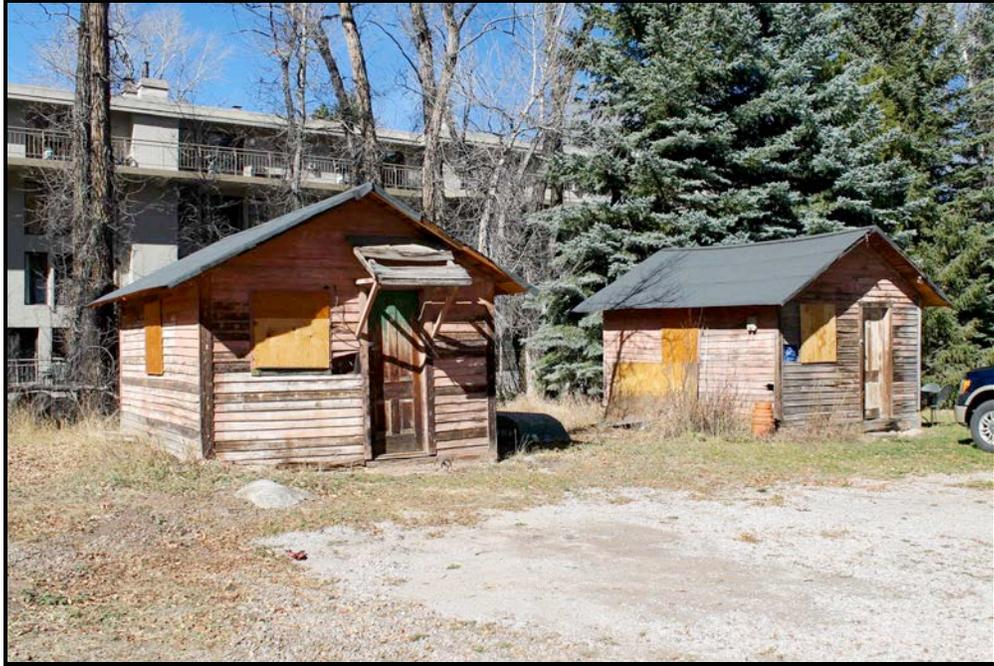
**North (right) and Center (left) Cabins Behind the Log Residence  
View to the Northwest**

**Northern Cabin (moved 1955):** This small wood frame building is located just southwest of the log house. Facing toward the east, it rests upon a concrete foundation and contains a single room. The exterior walls are finished with clapboard siding. The front-gabled roof is covered with newer rolled asphalt and the rafter ends are visible at the open eaves. While the exterior woodwork is weathered, remnants of old paint can still be seen. Evidence of recent stabilization work is minimally visible in several locations.

**Central Cabin** (moved 1955): Located just south of and adjacent to the north cabin, this small wood frame building faces toward the east, rests upon what is likely a stone foundation, and contains a single room. The exterior walls are finished with clapboard siding. The front-gabled roof is covered with newer rolled asphalt and the rafter ends are visible at the open eaves. While the exterior woodwork is weathered, remnants of old paint can still be seen. Evidence of recent stabilization work is minimally visible in several locations.

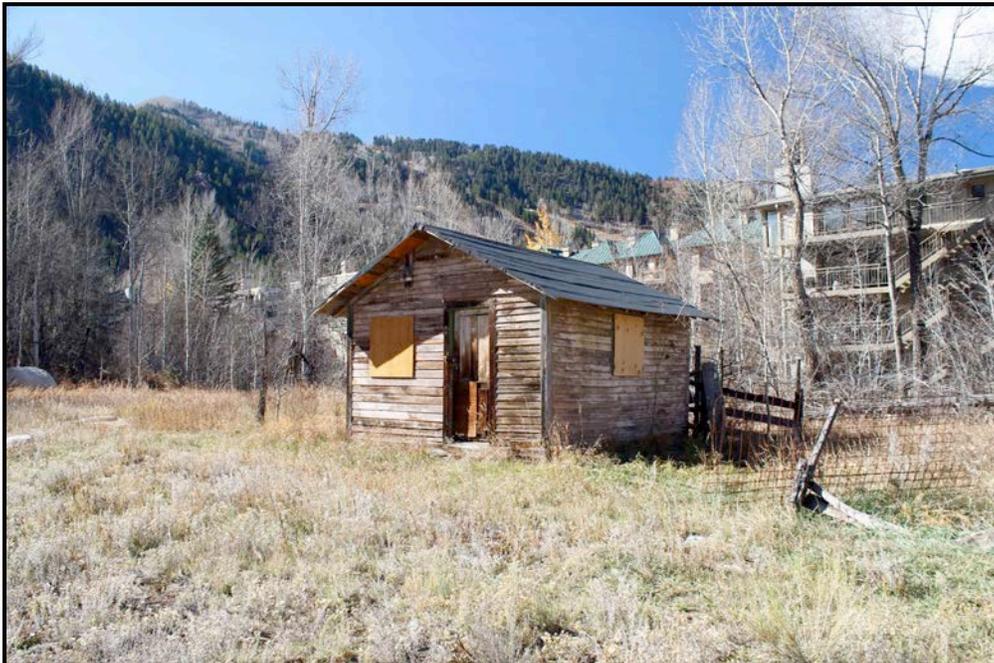
**South Cabin Near the Site's Southwest Corner  
View to the Southwest**

**Southern Cabin** (moved 1955): Located farther south of the central cabin in the southwest area of the site, this small wood frame building faces toward the east, rests upon what is likely a stone foundation, and contains a single room. The exterior walls are finished with clapboard siding. The front-gabled roof is covered with newer rolled asphalt and the rafter ends are visible at the open eaves. While the exterior woodwork is weathered, remnants of old paint can still be seen. Evidence of recent stabilization work is minimally visible in several locations.
